*California Department of Transportation
Division of Maintenance*

Structure Maintenance and Investigations

Bridge Number : 10 0136
Facility Carried: STATE ROUTE 1
Location : 01-MEN-001-43.74
City :
Inspection Date : 10/06/2015

STRUCTURE NAME: ALBION RIVER

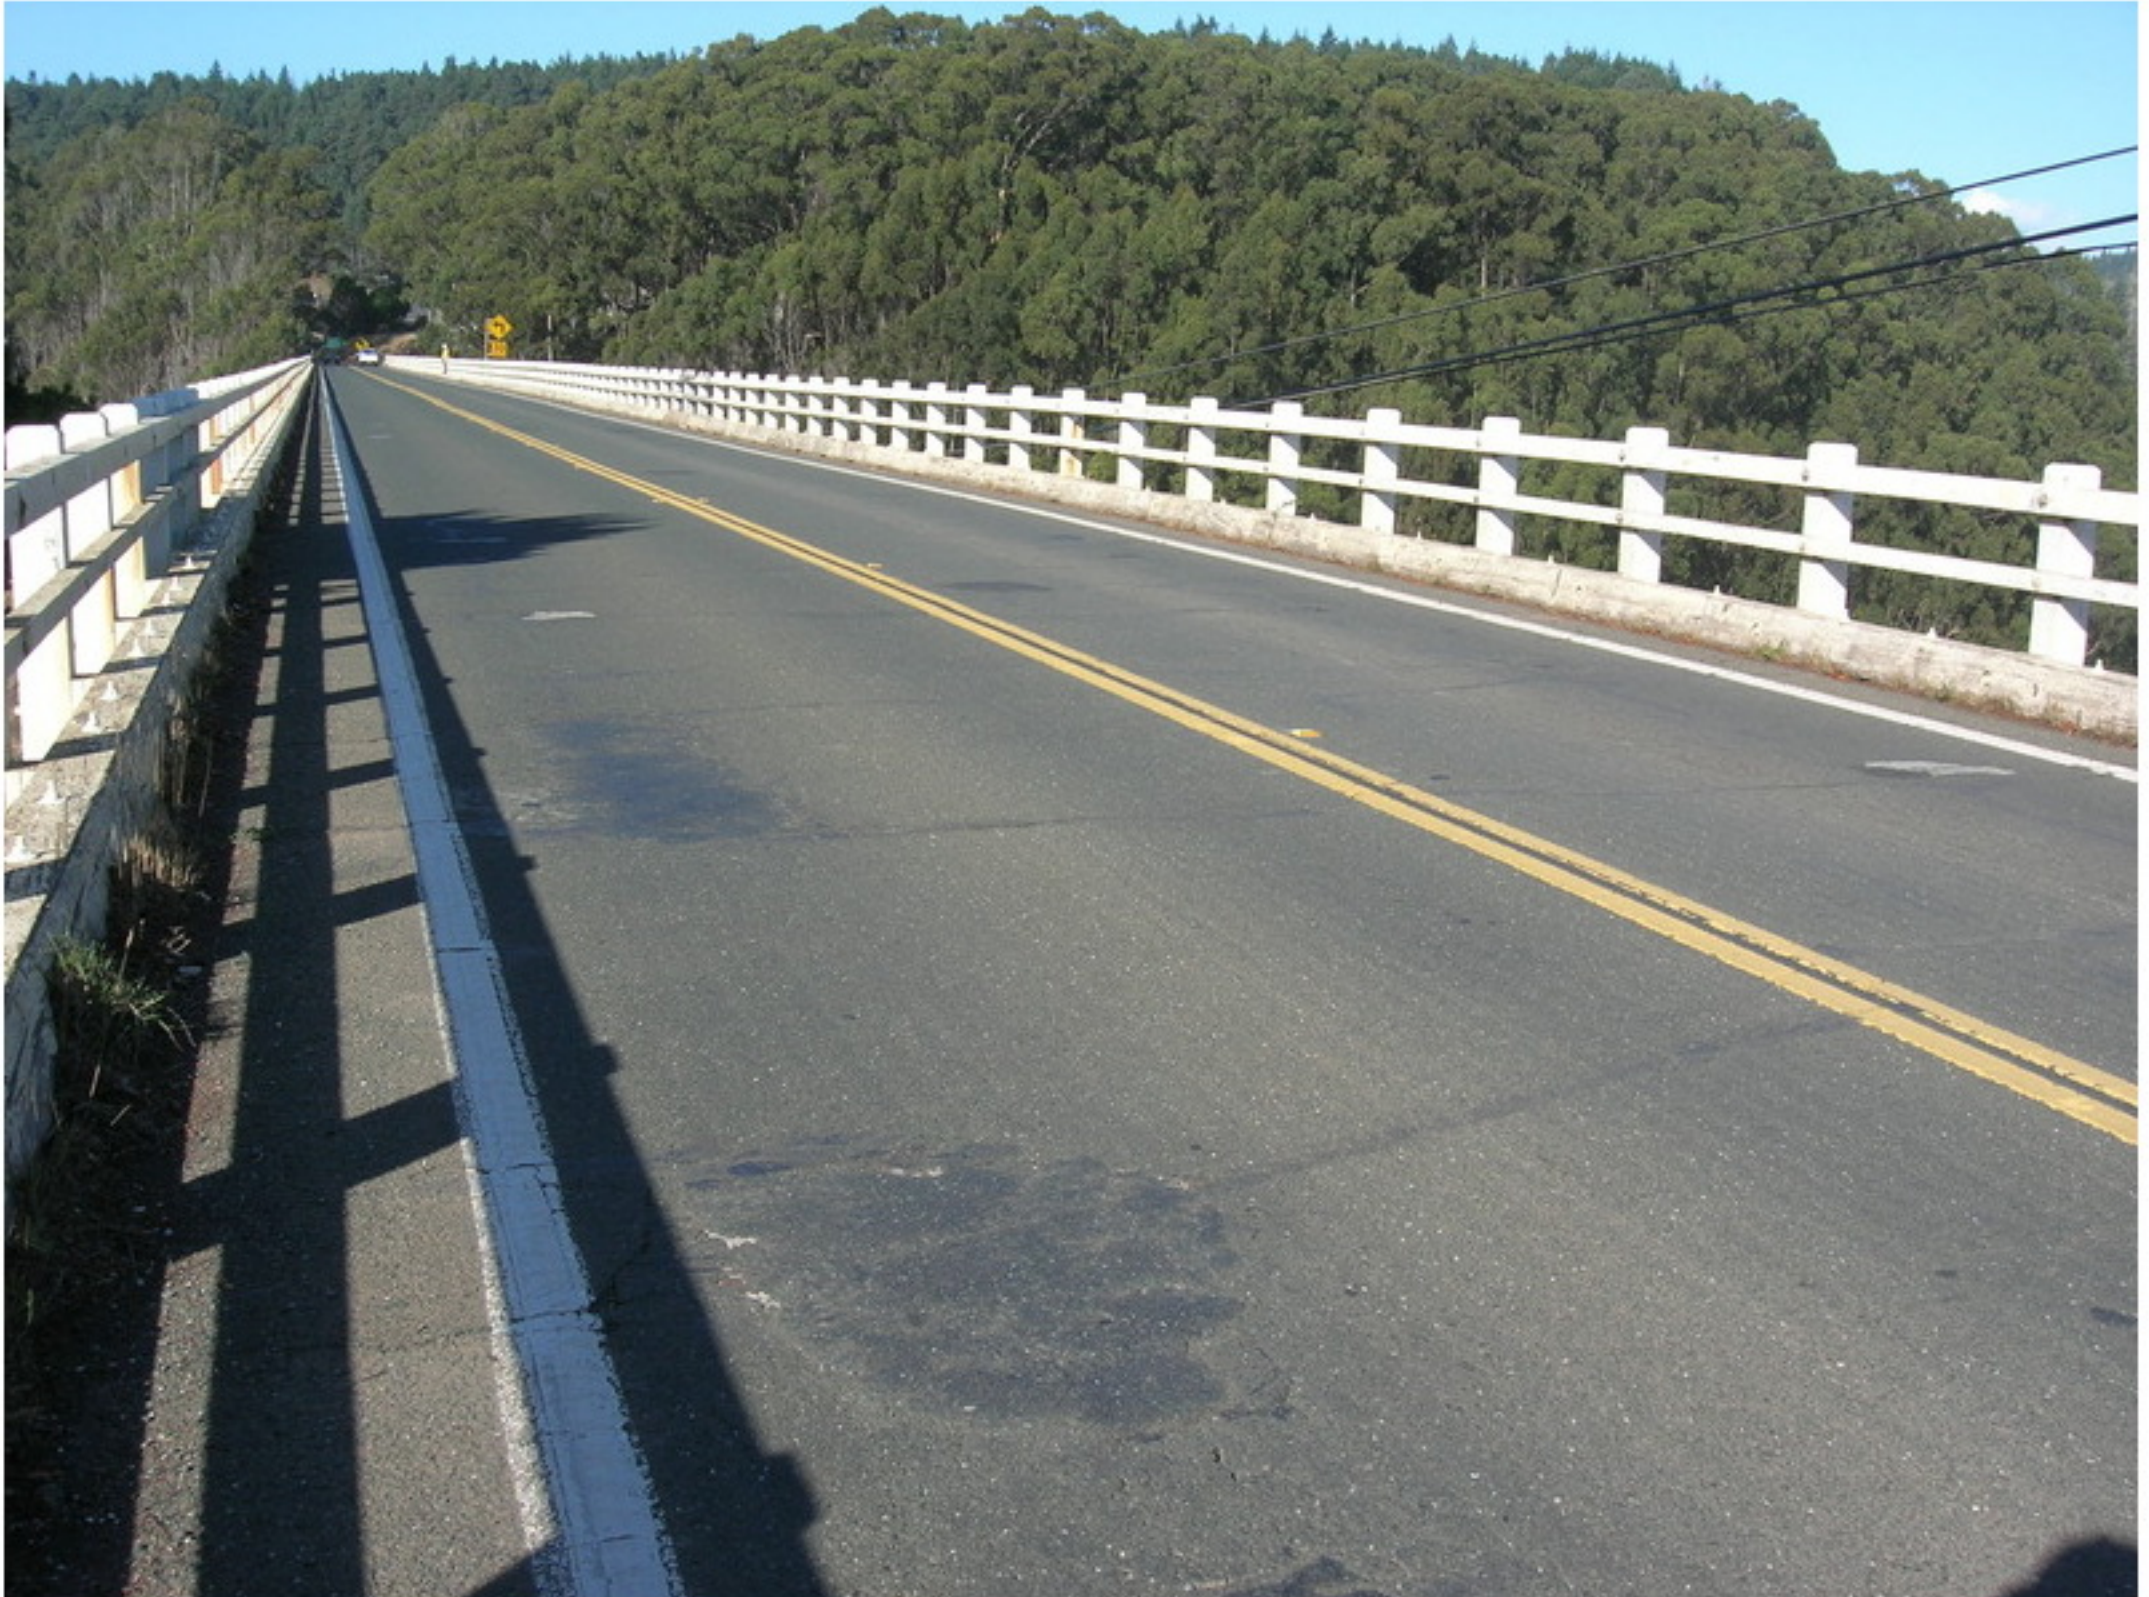
Photo No. 5

Repaired potholes in the AC in the southbound lane of one of the southern approach spans

There are numerous repaired, patched, and cracked and raveled areas in both lanes in nearly all spans. The cracking, raveling, and potholing of the AC indicates that the timber two-layer plank deck under the AC is rotting and crushing, causing the failure of the AC riding surface. The timber plank deck appears to have reached the end of its service life. Remove the AC; remove and replace any deteriorated timber planks; place a new waterproof membrane on the timber planks; place a new course of AC on the membrane.

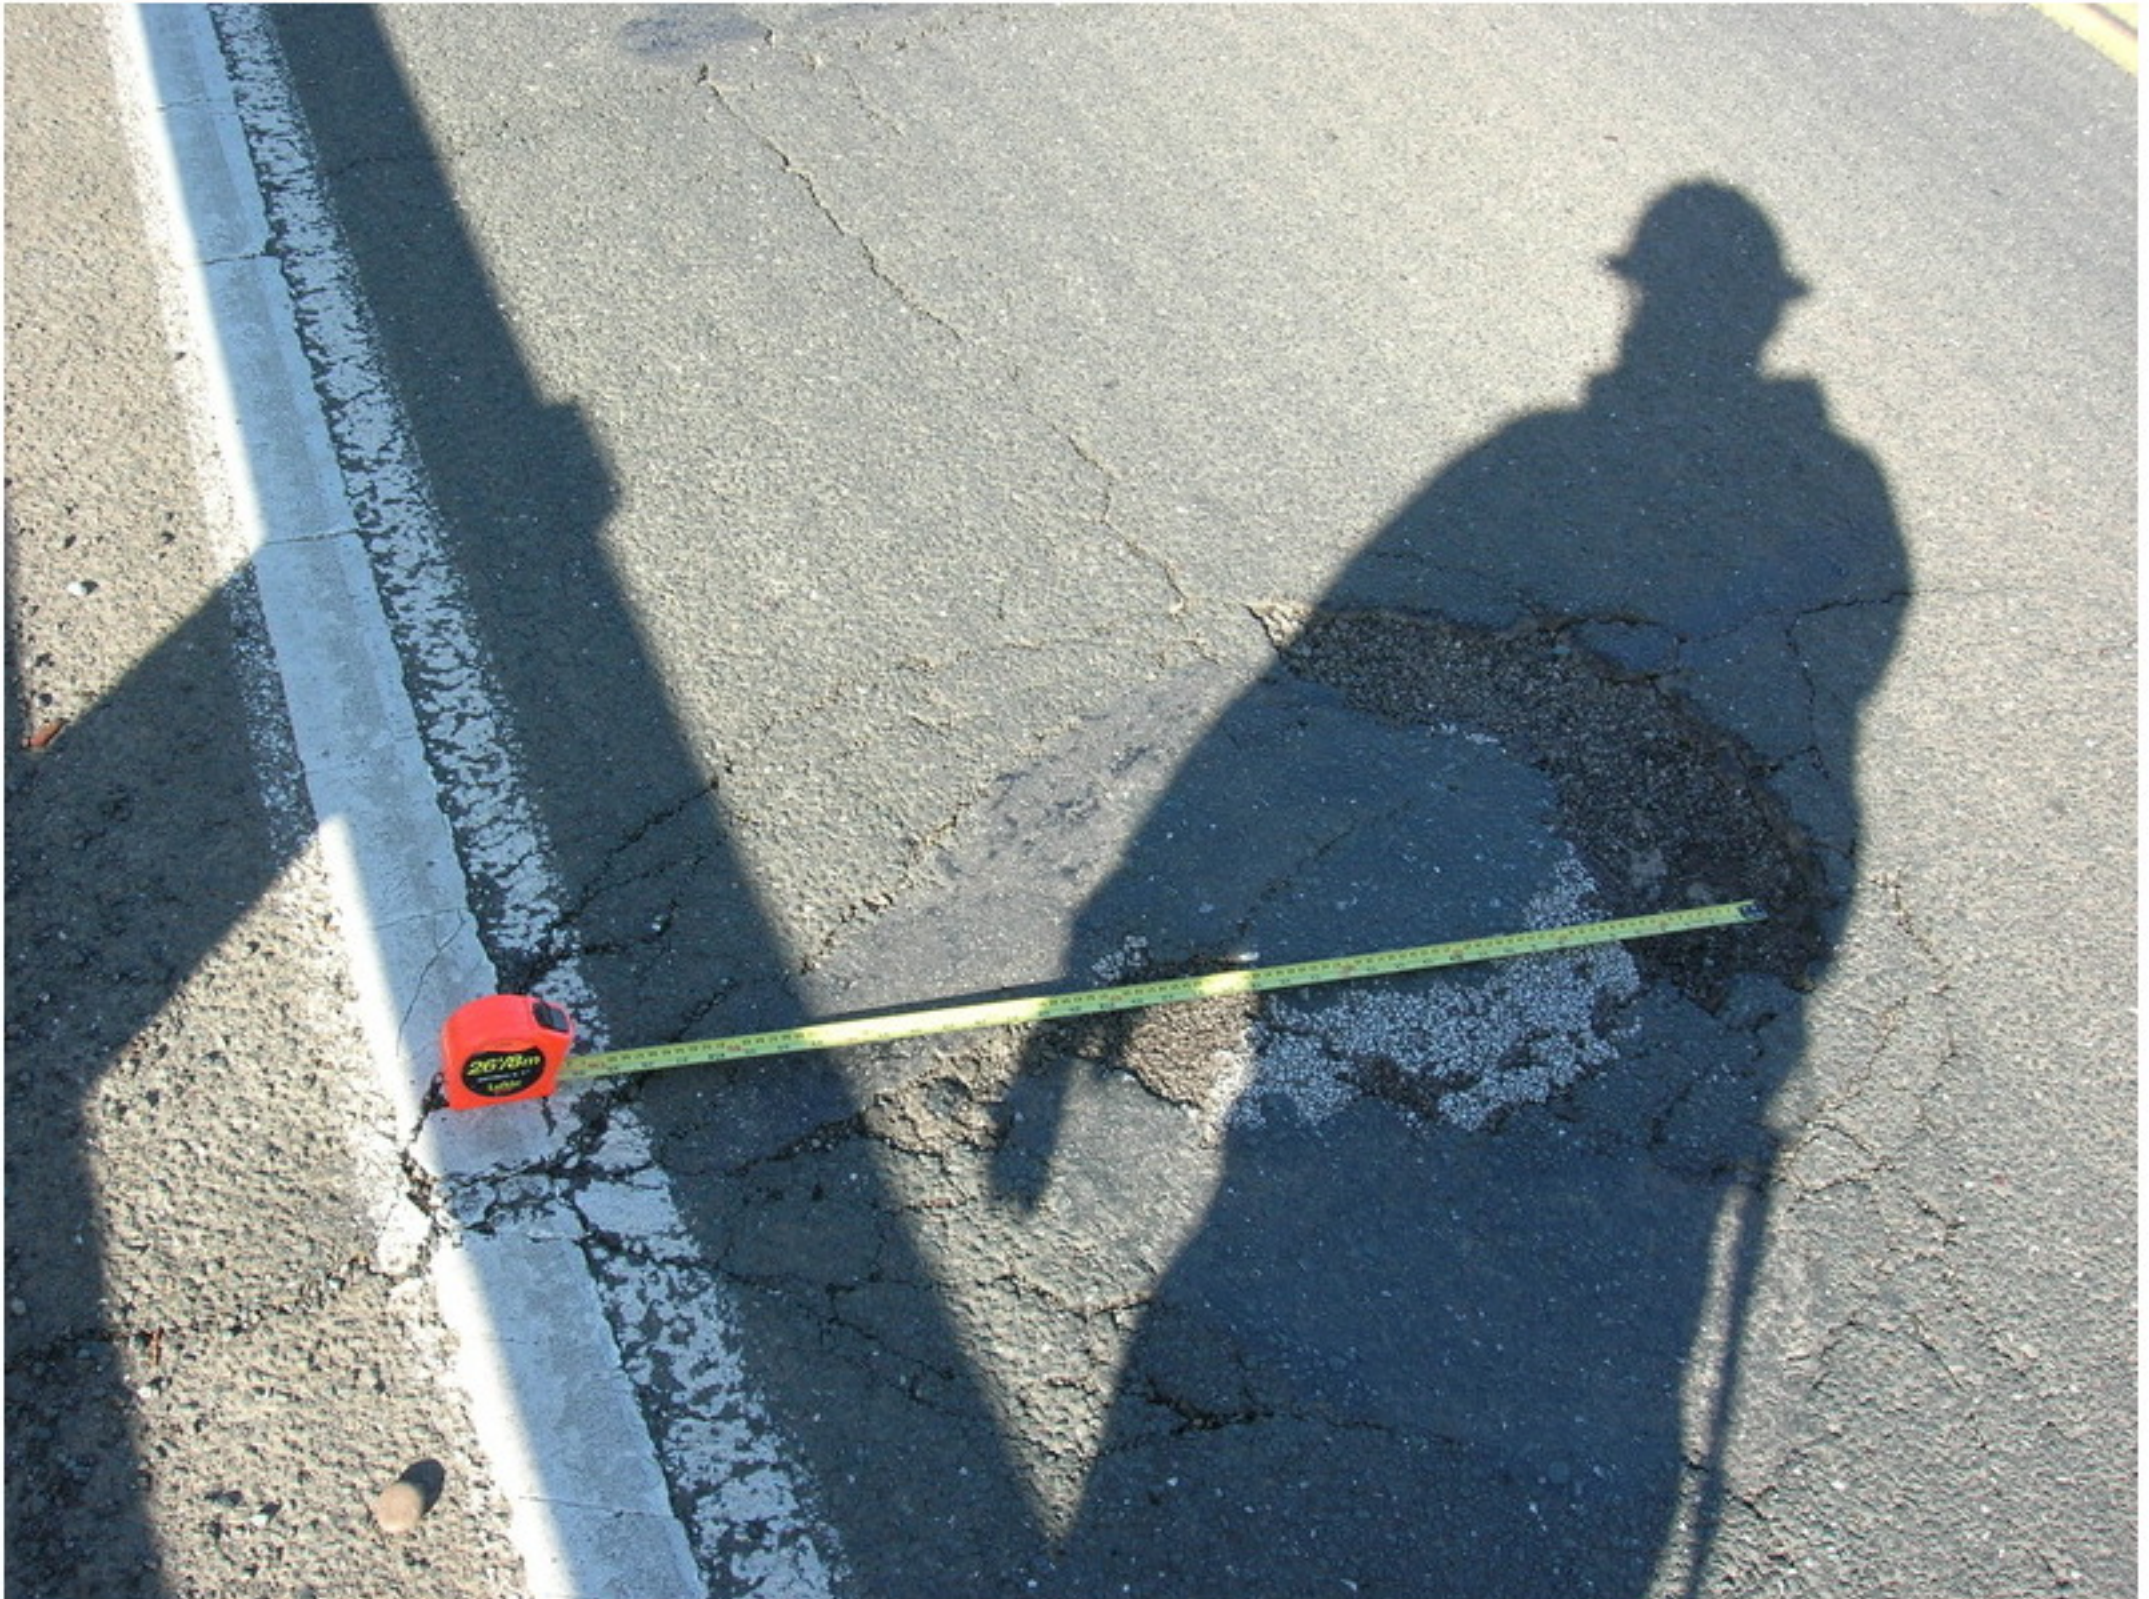
Photo No. 6
Patched pothole in the AC in the southbound lane of one of the southern approach spans

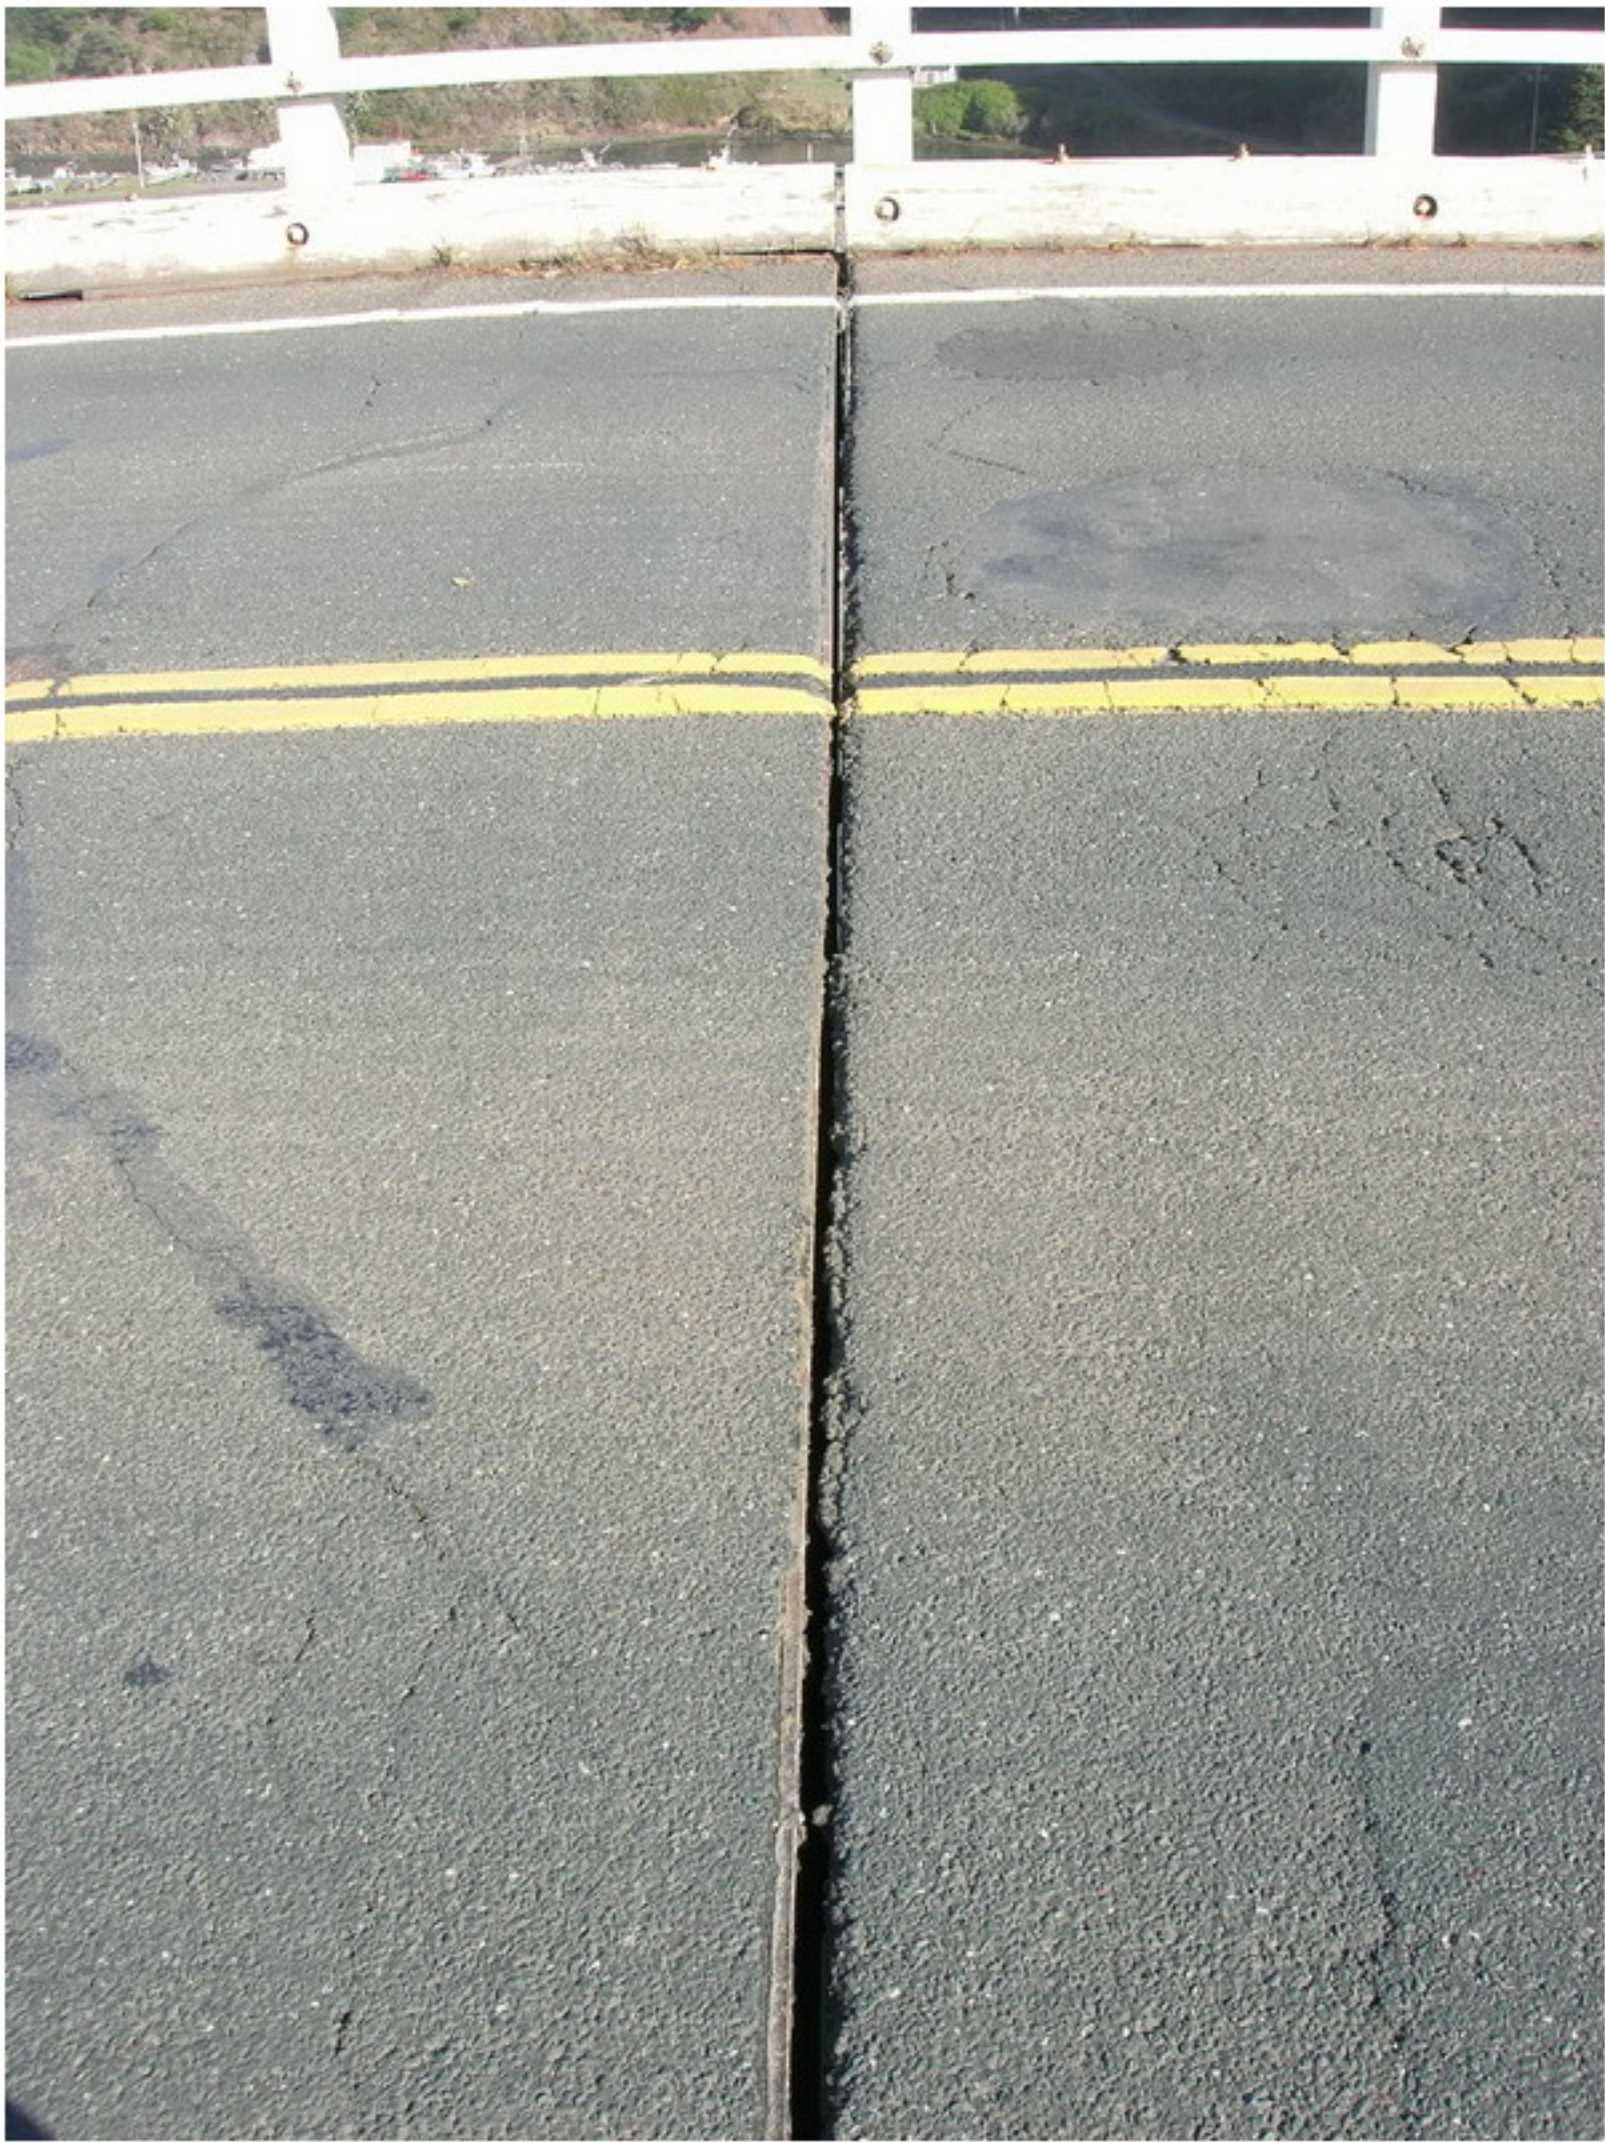
Photo No. 7
Raveled AC in the southbound lane at expansion joint at south end of the main span - B12

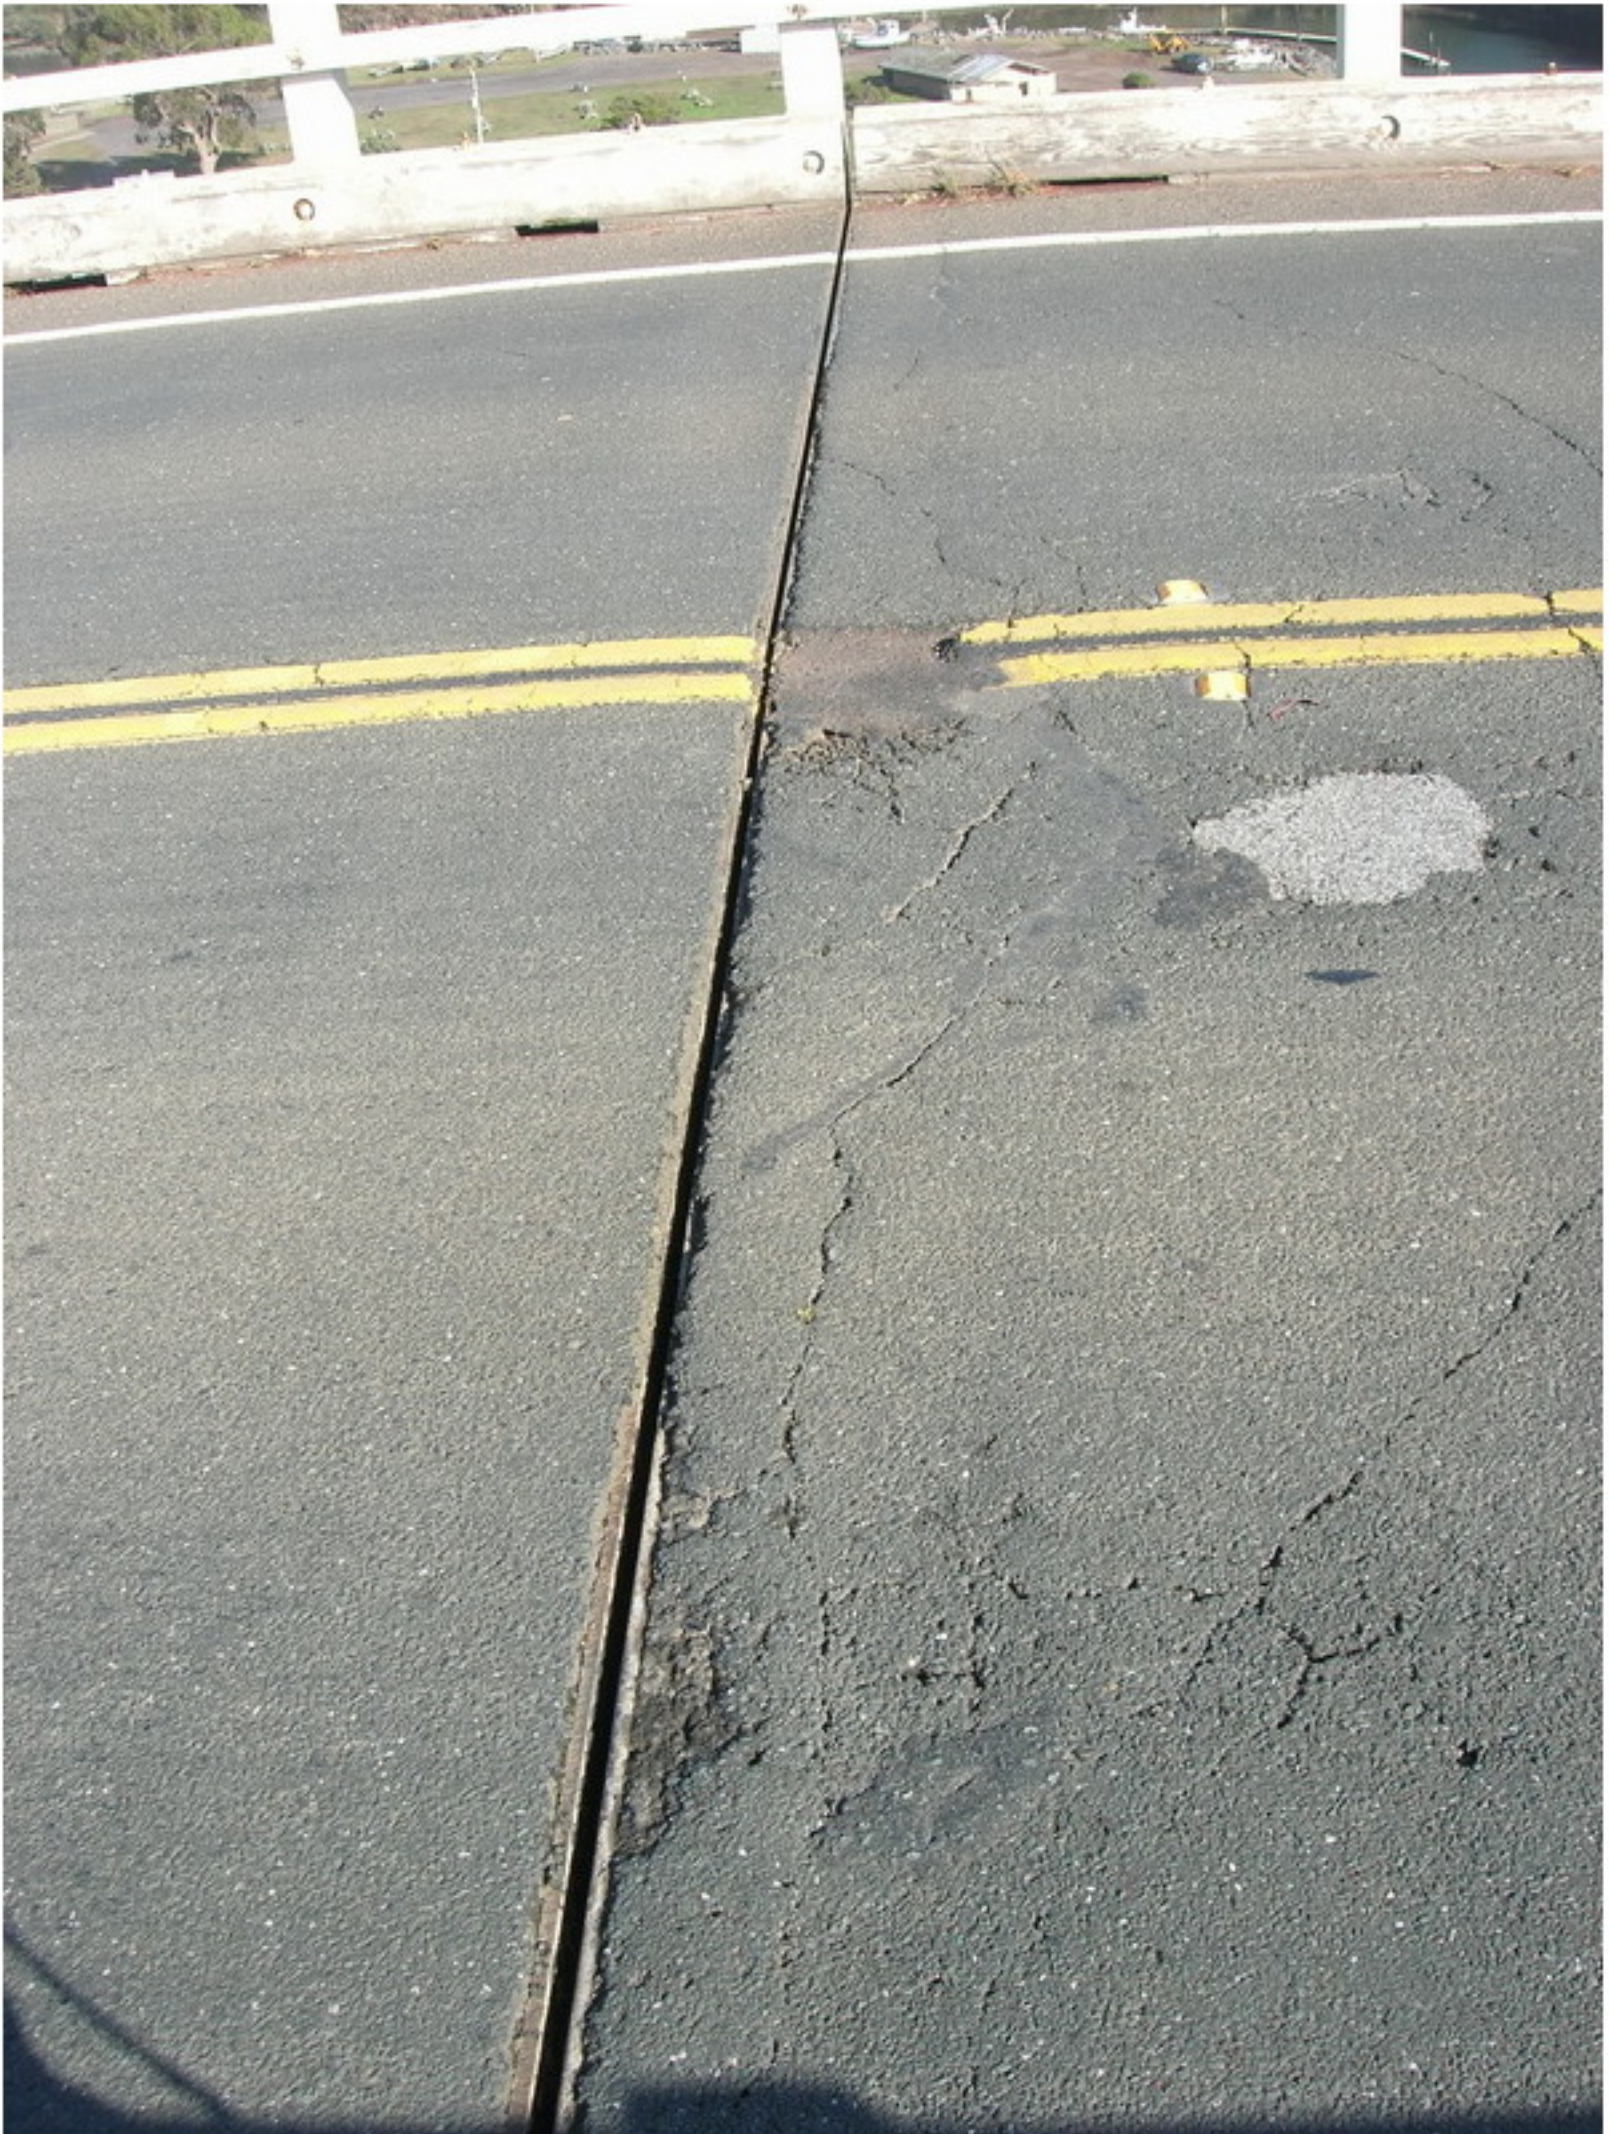
Photo No. 8

The AC of the north end southbound lane in Span 12, adjacent to the open expansion joint at Bent 13, has patched potholes, map pattern cracks, and raveling.

Patched & raveled AC in southbound lane at expansion joint at north end of main span - B13

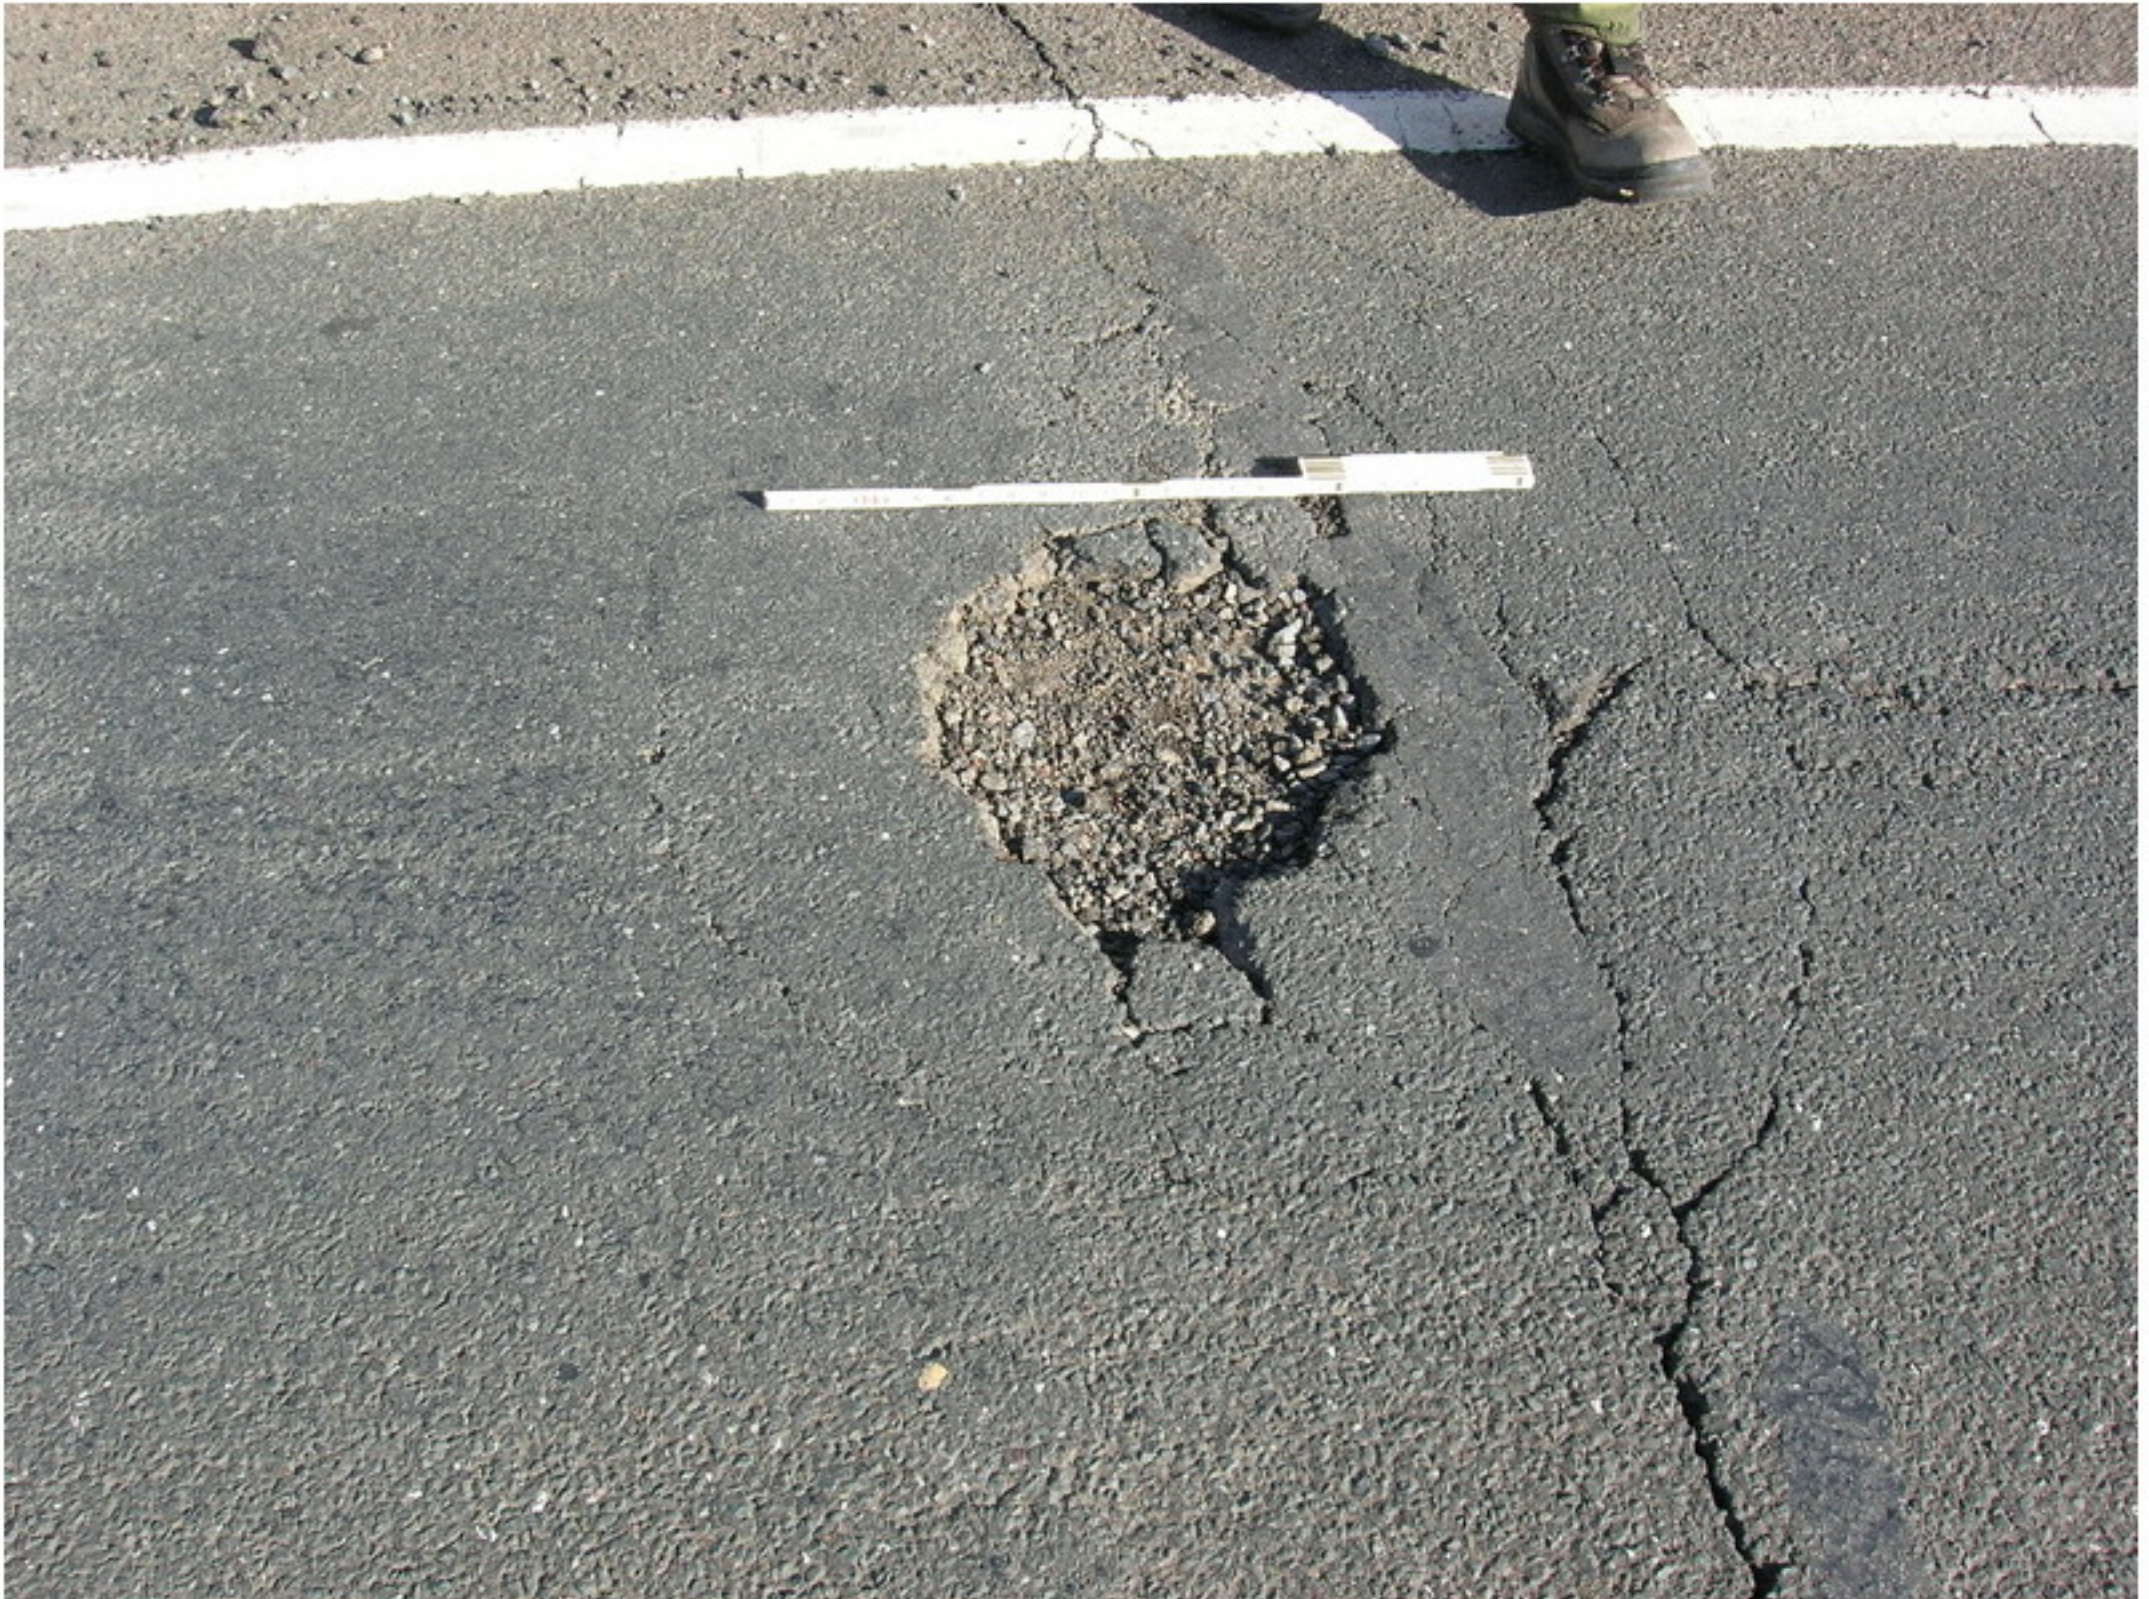
Photo No. 9
Pothole in the AC in the northbound lane of one of the northern approach spans

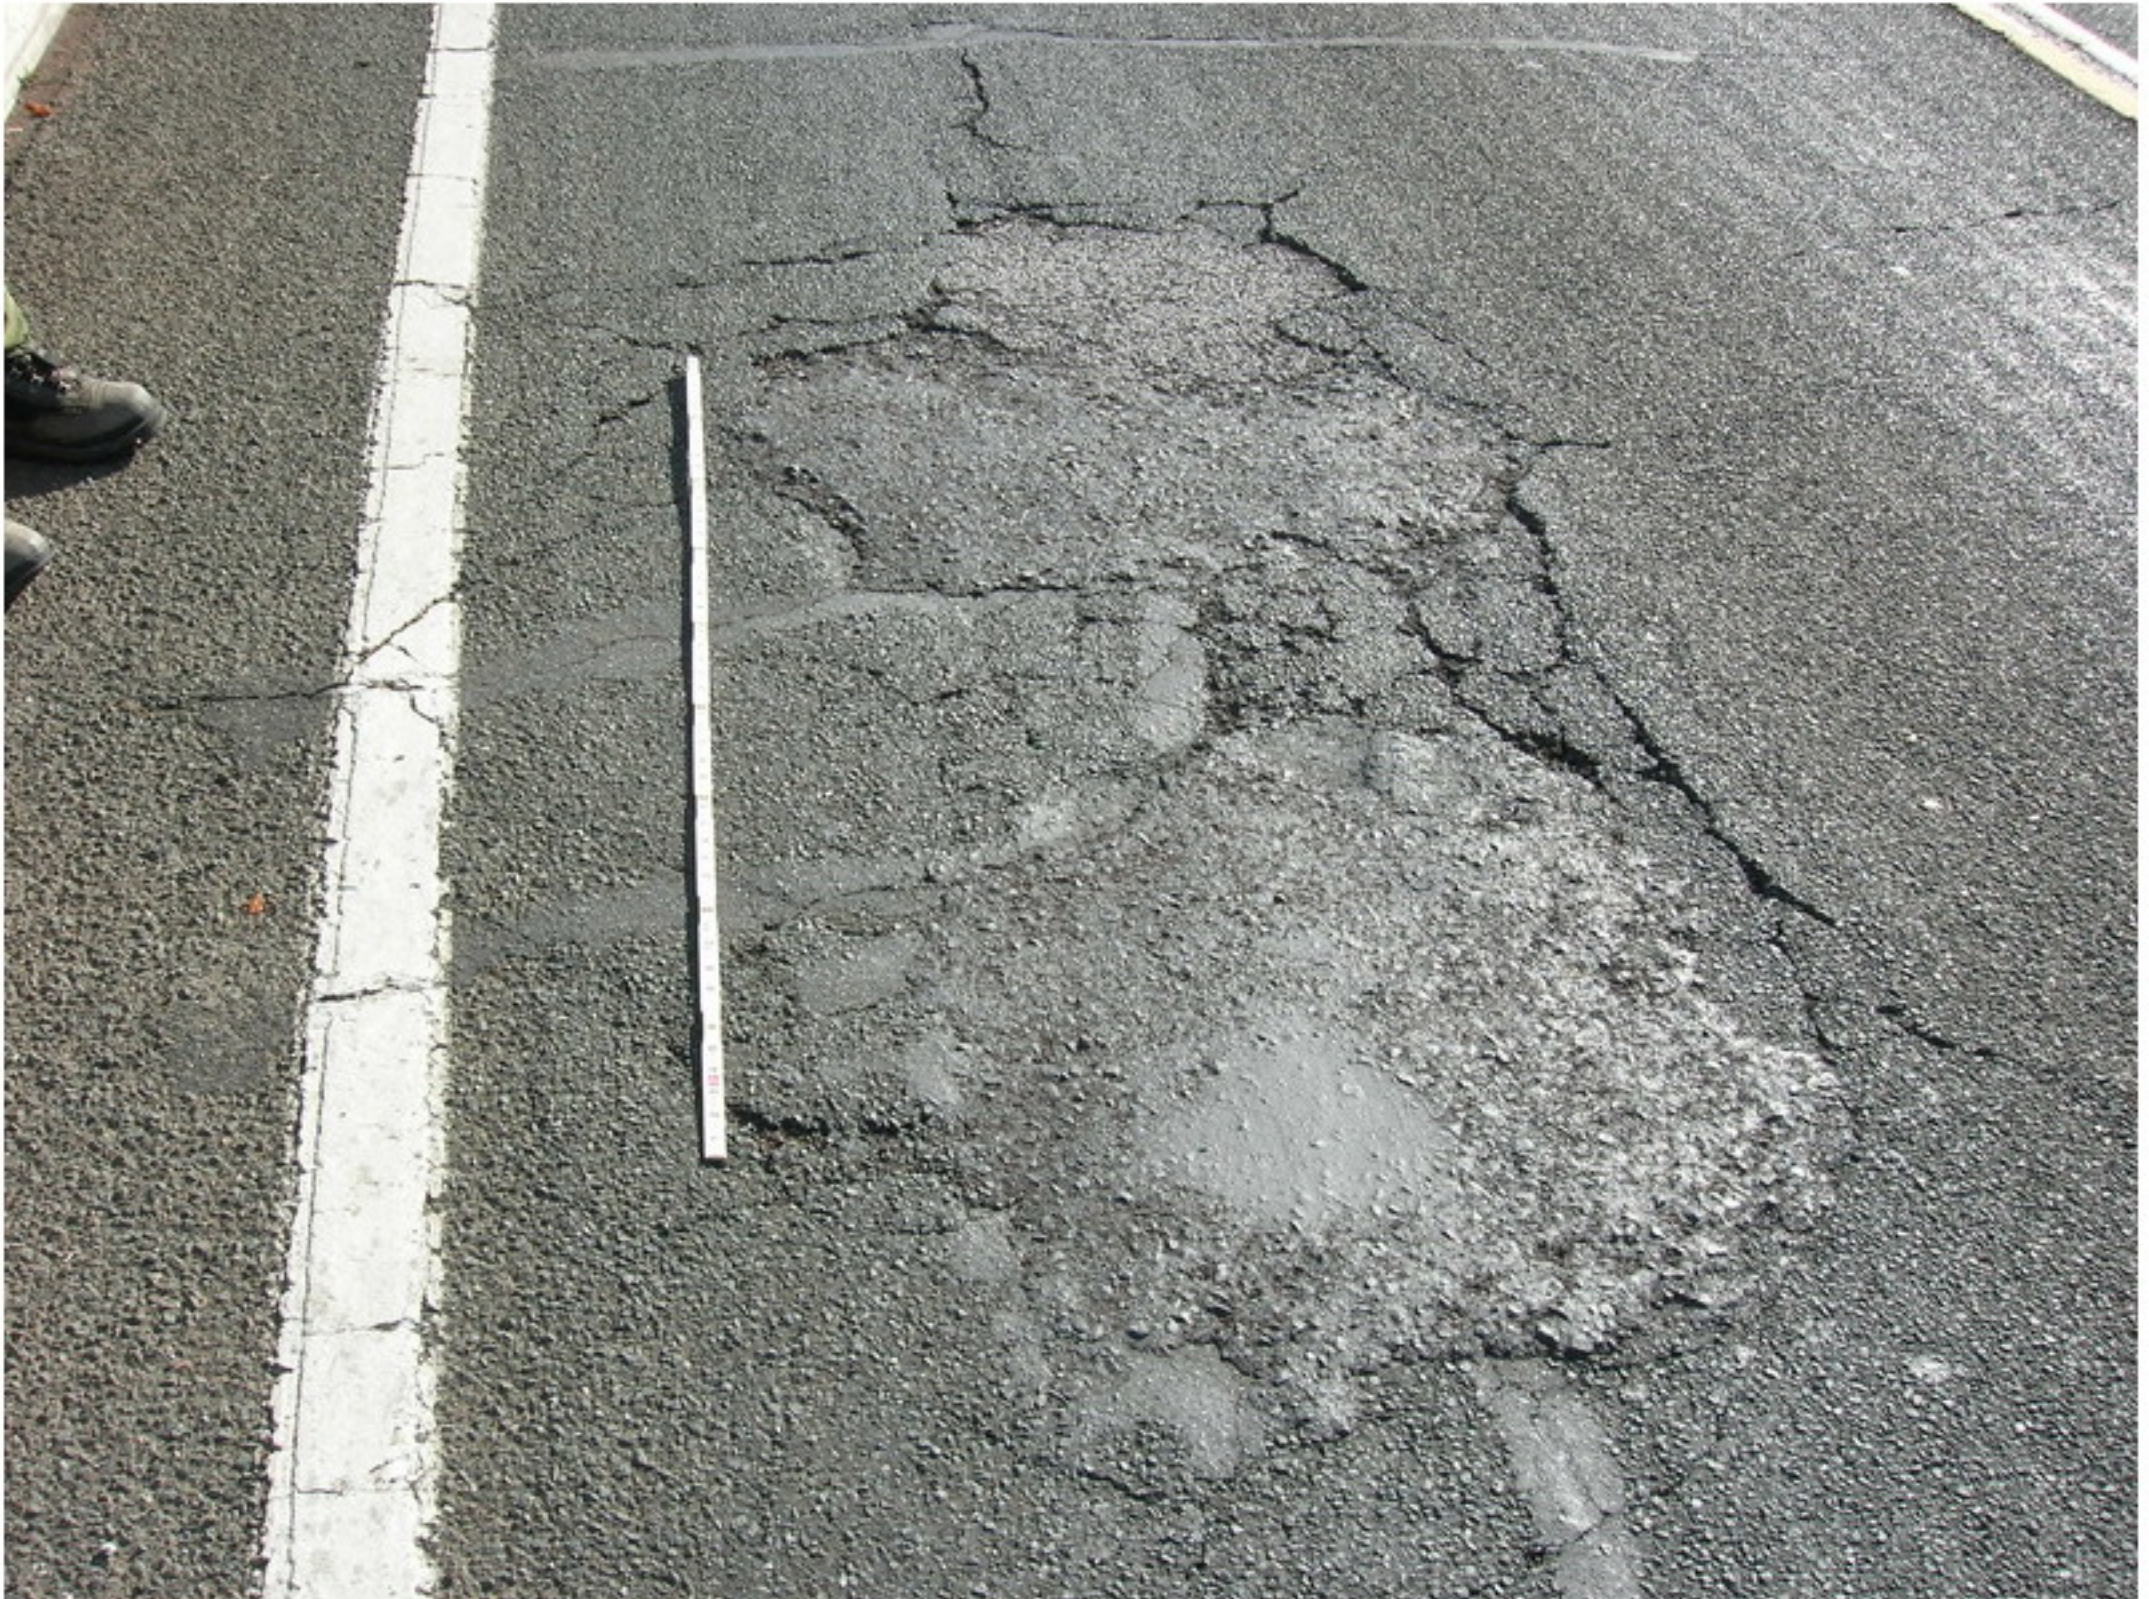
Photo No. 10

Repaired pothole in the AC in the northbound lane of one of the northern approach spans
